FACILITY CONDITION ASSESSMENT

MH/MR GROUP HOME #5024

161 West Main Street

Date of Report: June 25, 2007

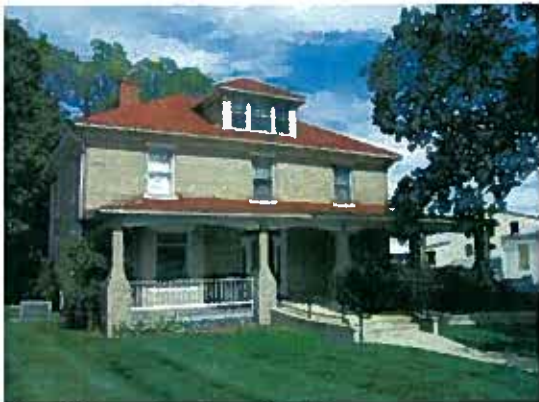
Photo #1: Front elevation of building

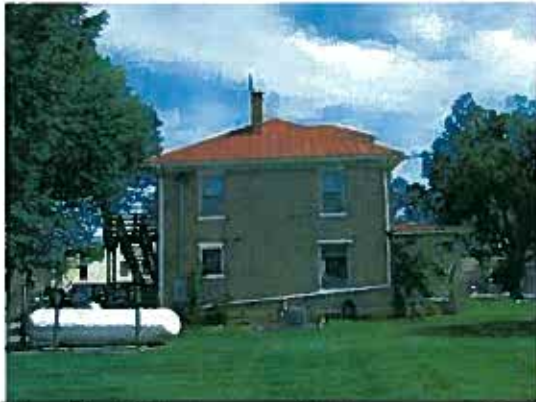
Photo #2: Left side elevation of building

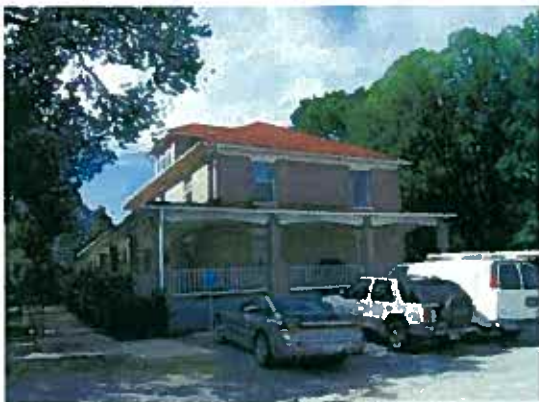
Photo #3: Right side elevation of building

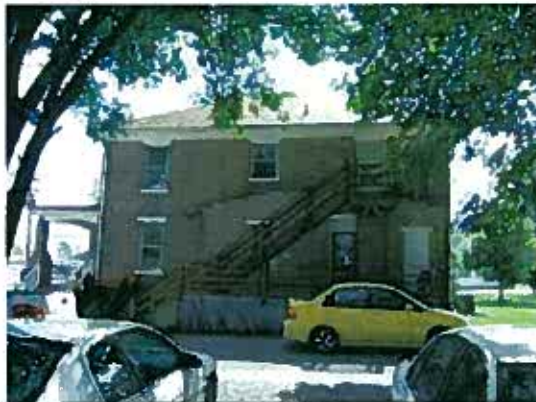
Photo #4: Rear elevation of building

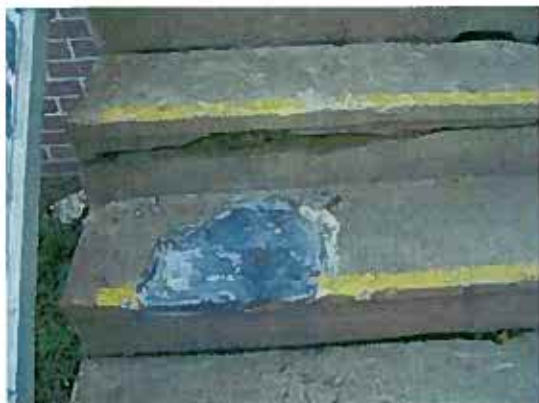
Photo #5: Damaged steps

- The property does not have a dedicated parking lot repair and maintenance contractor. County maintenance maintain the gravel lot and flatwork or a contractor is retained when required.
- The concrete steps located on the northeast corner of the building are in fair condition. Significant areas of settlement, cracking, and spalling concrete occur. The damaged areas of concrete steps will require replacement during the evaluation period. The estimated cost of this work is included as a lump sum in the Deficiency Cost Table and is considered a Priority 2 corrective action.

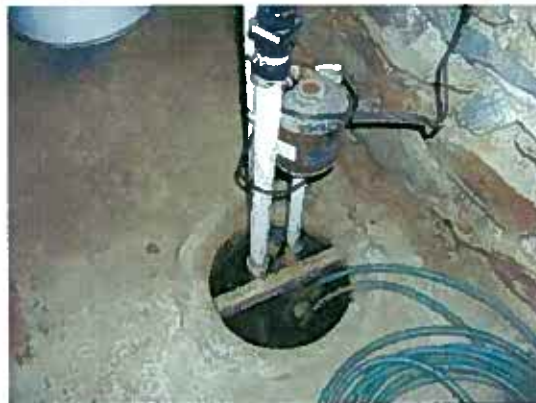
Photo #6: Sump pump in basement

- There is no evidence of storm water runoff from adjacent properties. The storm water system appears to provide adequate runoff capacity. There is no evidence of major ponding or erosion.
- The plastic sump and sump pump are reported to be in good condition. Based on the estimated Remaining Useful Life (RUL), the sump pump will require replacement during the evaluation period. The estimated cost of this work is included as a lump sum in the Deficiency Cost Table and is considered a Priority 3 corrective action.

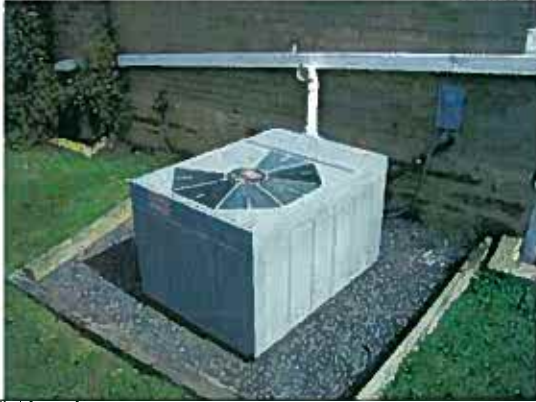
Photo #7: Pad-mounted heat pump

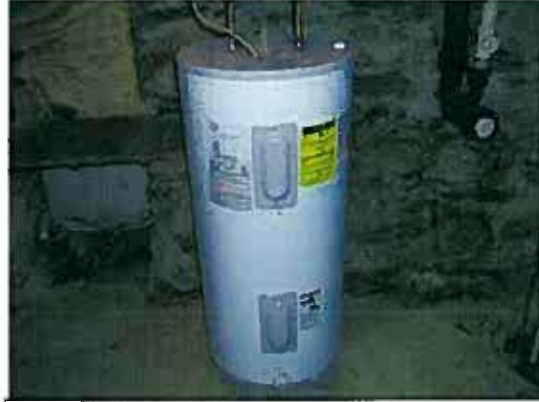
Photo #8: Water heater

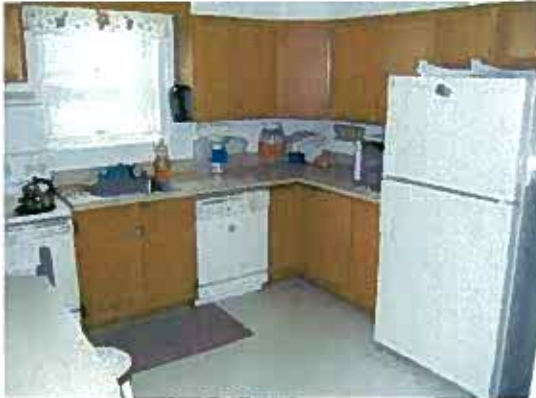
Photo #9: Kitchen equipment

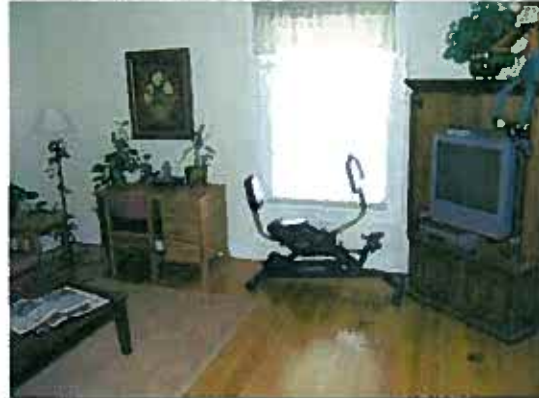
Photo #10: TV/lounge area

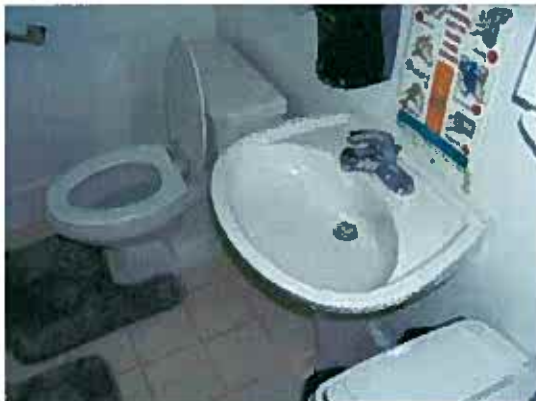
Photo #11: Non-compliant ADA bathroom

Corrections of these conditions should be addressed from a liability standpoint, but are not necessarily code violations. The Americans with Disabilities Act Accessibility Guidelines concern civil rights issues as they pertain to the disabled and are not a construction code, although many local jurisdictions have adopted the Guidelines as such. The cost to address the achievable items noted above is \$2,910 and is included as a lump sum in the Deficiency Cost Table as a Priority 1 corrective action.

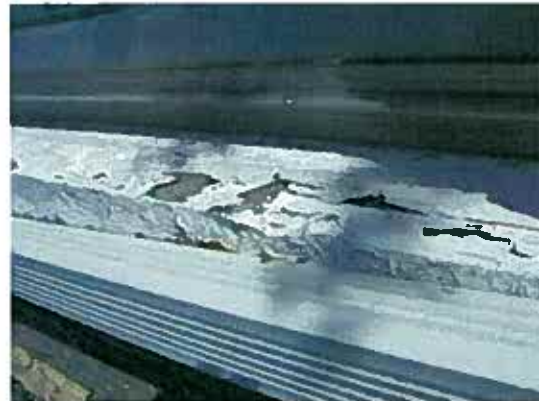
Photo #12: Weathered window sills

- There is evidence of window leaks and condensation. The windows are in fair condition. Based on their condition and estimated Remaining Useful Life (RUL), the windows will require painting during the assessment period. This is considered a Priority 2 corrective action, and the cost is included with the painting of the house trim in Section 6.4. Additionally, based on their estimated Remaining Useful Life, replacement during the assessment period will be required. This is considered a Priority 3 corrective action.
- The exterior doors and door hardware are in good condition and will require routine maintenance during the assessment period.

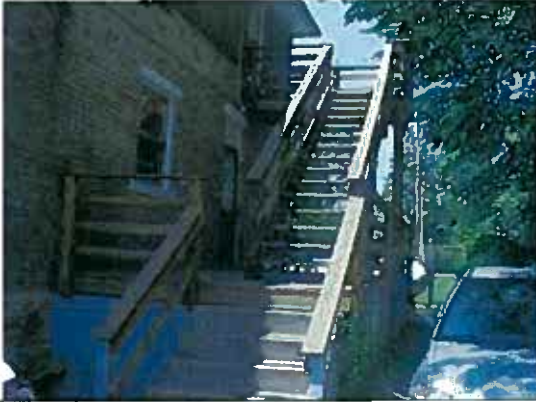
Photo #13: Rear wood fire escape

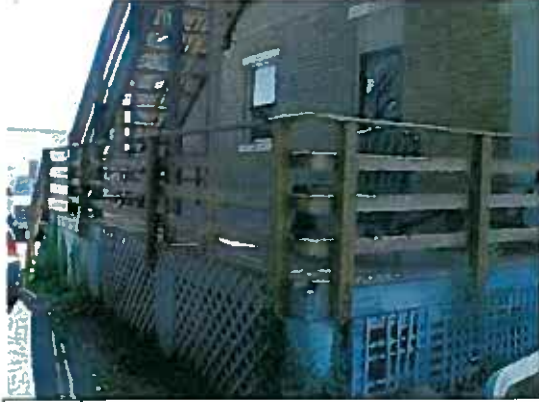
Photo #14: Rear wood porch

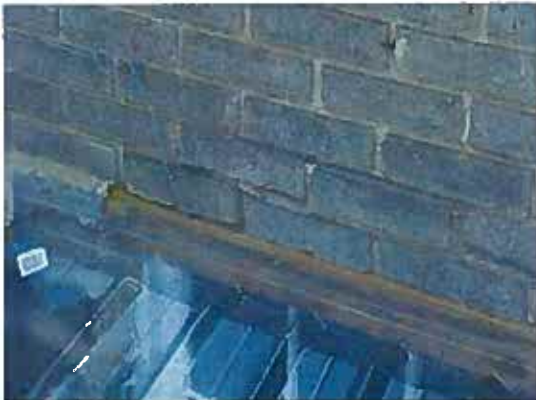
Photo #15: Dislodged brick on west side of property

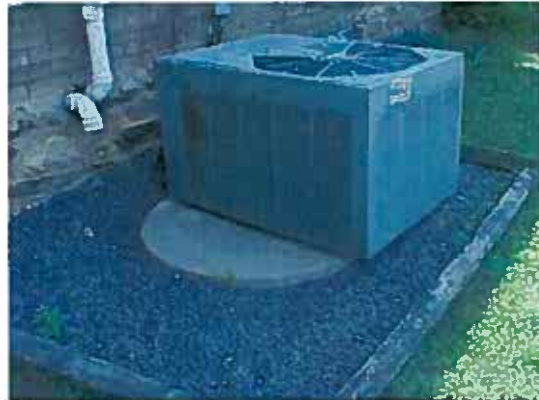
Photo #16: HVAC unit has vibrated off its pad

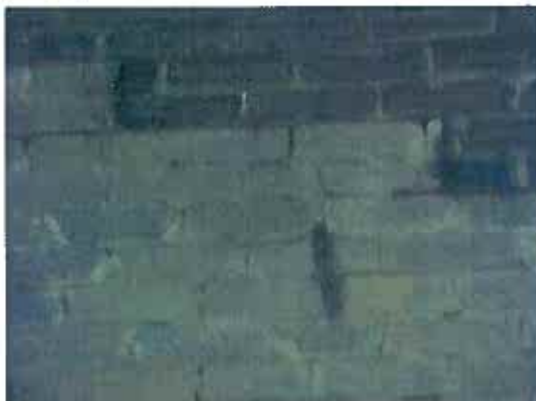
- The brick masonry veneer is in fair condition. Isolated portions of the mortar joints are cracked along the north and west elevations of the building. The brick mortar will require cleaning and re-pointing will require replacement during the evaluation period. The estimated cost of this work is included in the Deficiency Cost Table and is considered a Priority 2 corrective action.

Photo #17: Tuckpointing of brick required

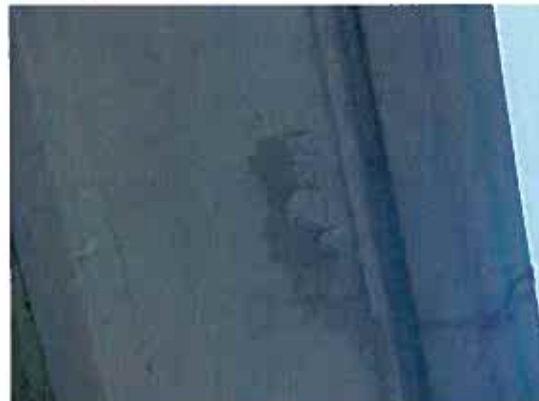
Photo #18: Damaged and peeling paint on exterior trim

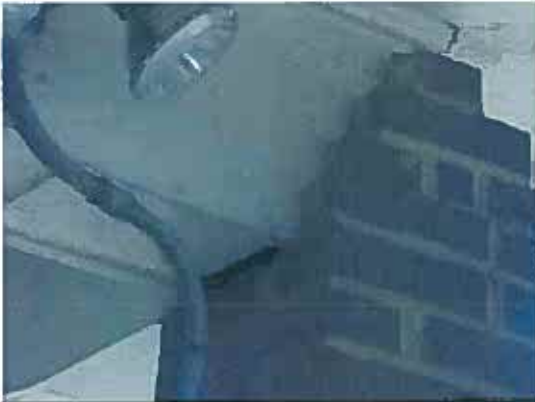
- For the front porch, a brick column that supports the roof structure is showing signs of movement. Further investigation and corrective action is recommended. The estimated cost of this work is included as a lump sum in the Deficiency Cost Table and is considered a Priority 1 corrective action.

Photo #19:	Brick column supporting the porch roof structure (signs of movement)
------------	--

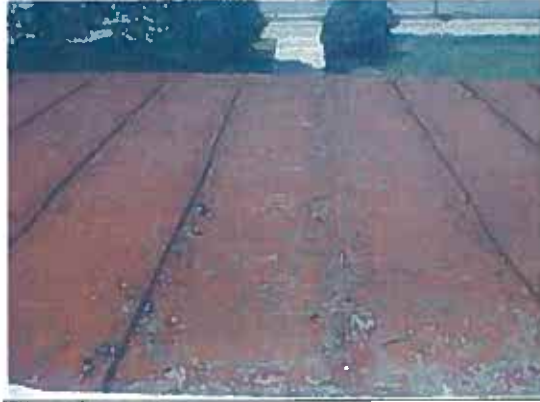
- The roof is in fair condition with rust evident on the metal roof. Based on the estimated Remaining Useful Life (RUL) and current condition, the metal roofing will require replacement. The estimated cost of this work is included as a lump sum in the Deficiency Cost Table and is considered a Priority 2 corrective action.

Photo #20:	Rust on standing seam metal roof
------------	----------------------------------
